# GEOLOGIC CHARACTERIZATION OF LAKE DISSTON FLAGLER COUNTY, FLORIDA

By  
Jack L. Kindinger<sup>1</sup>, Jeffrey B. Davis<sup>2</sup>, and James G. Flocks<sup>1</sup>  
1997

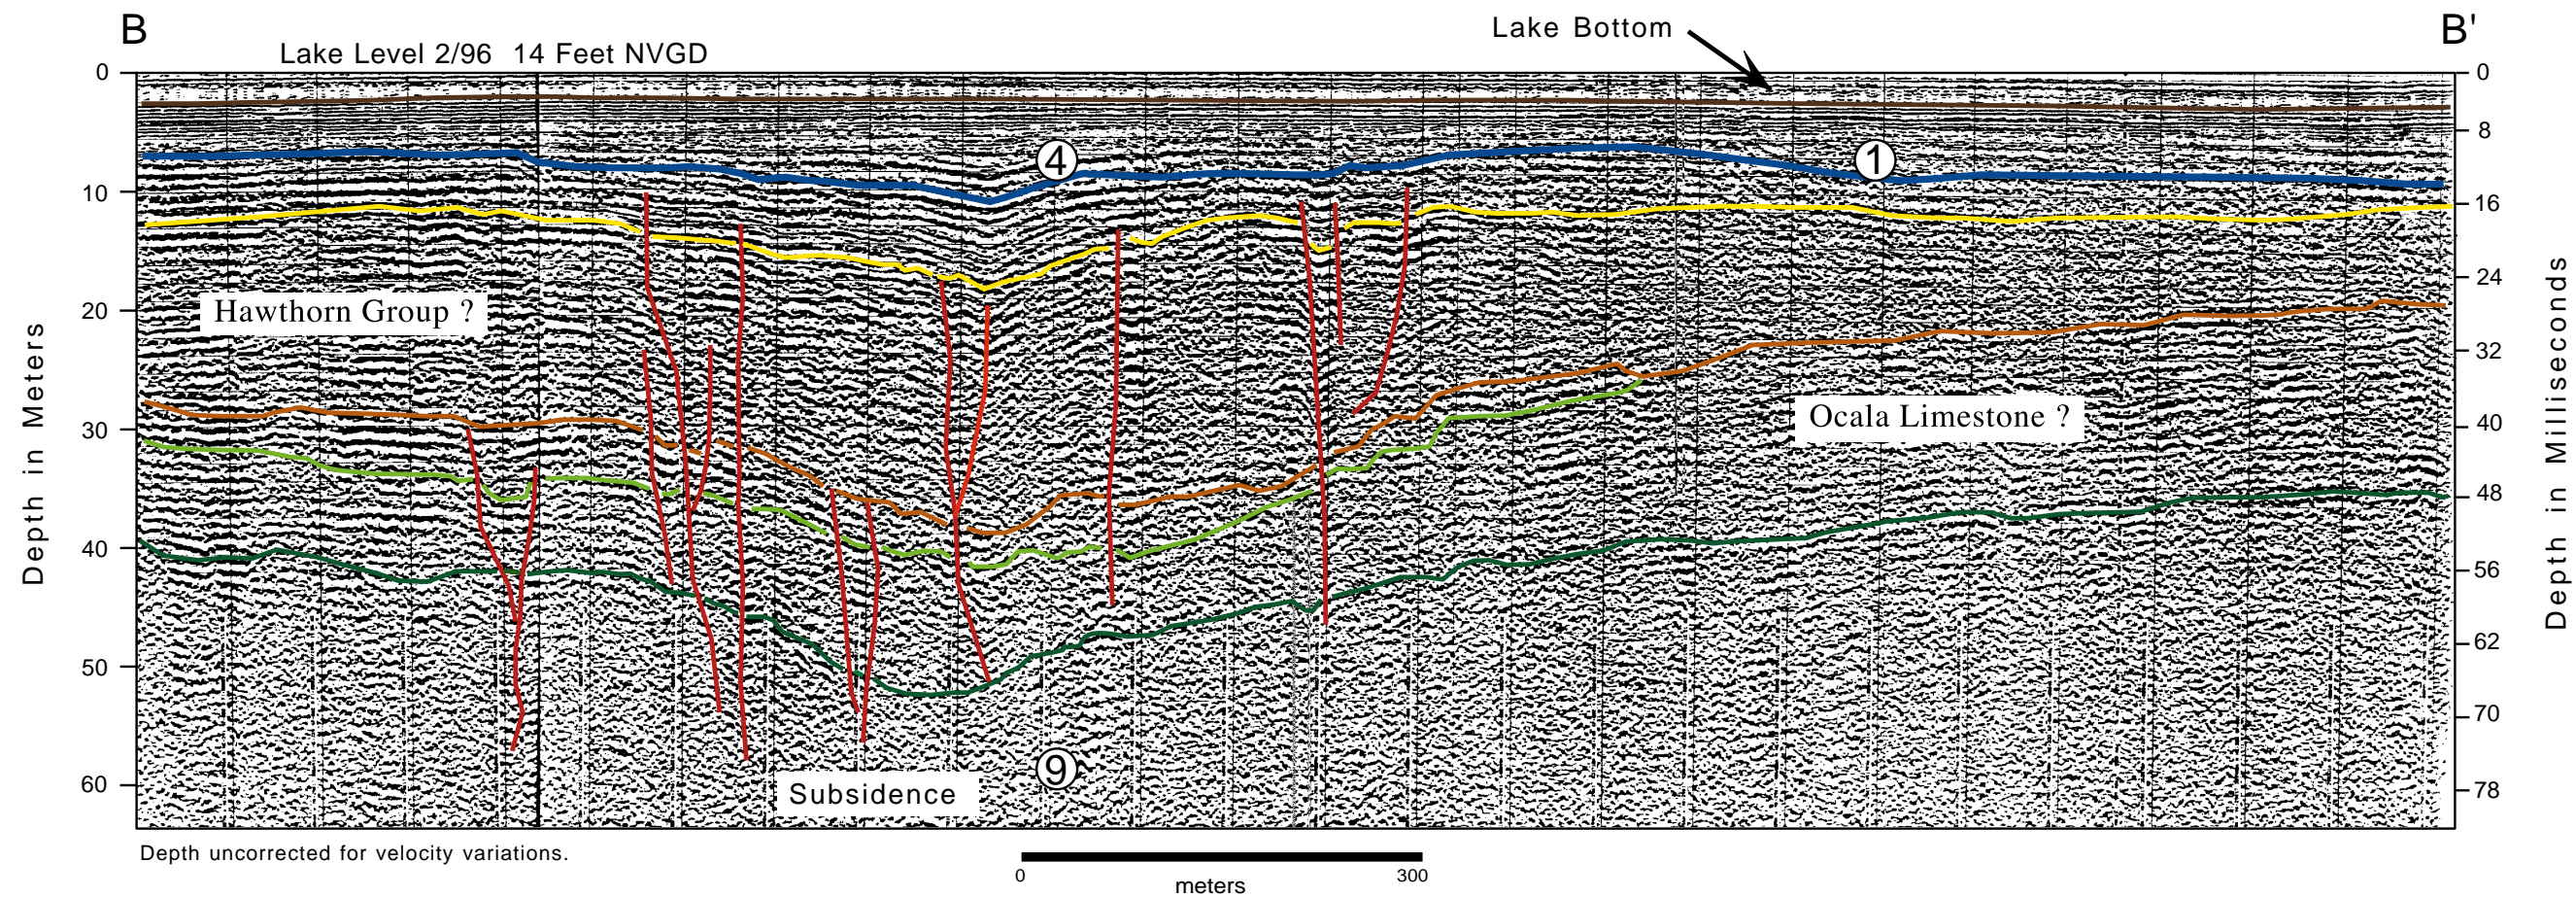
Logs from wells in the area have shown the depth to the top of the Ocala Limestone to be -9 to -18 m (-30 to -60 ft) NVGD. Not knowing the actual velocities of the substrate has not allowed us to absolutely pick this reflector. Using the geometry of the units from the seismic profiles we have identified the confining layer (Hawthorn Group?) and the top of the limestone (Ocala Limestone?), Profile B-B'.
